APOLLO PROGRAM

FINAL FLIGHT EVALUATION REPORT APOLLO 6 MISSION

FEBRUARY, 1969

NATIONAL AERONAUTICS AND SPACE ADMINISTRATION

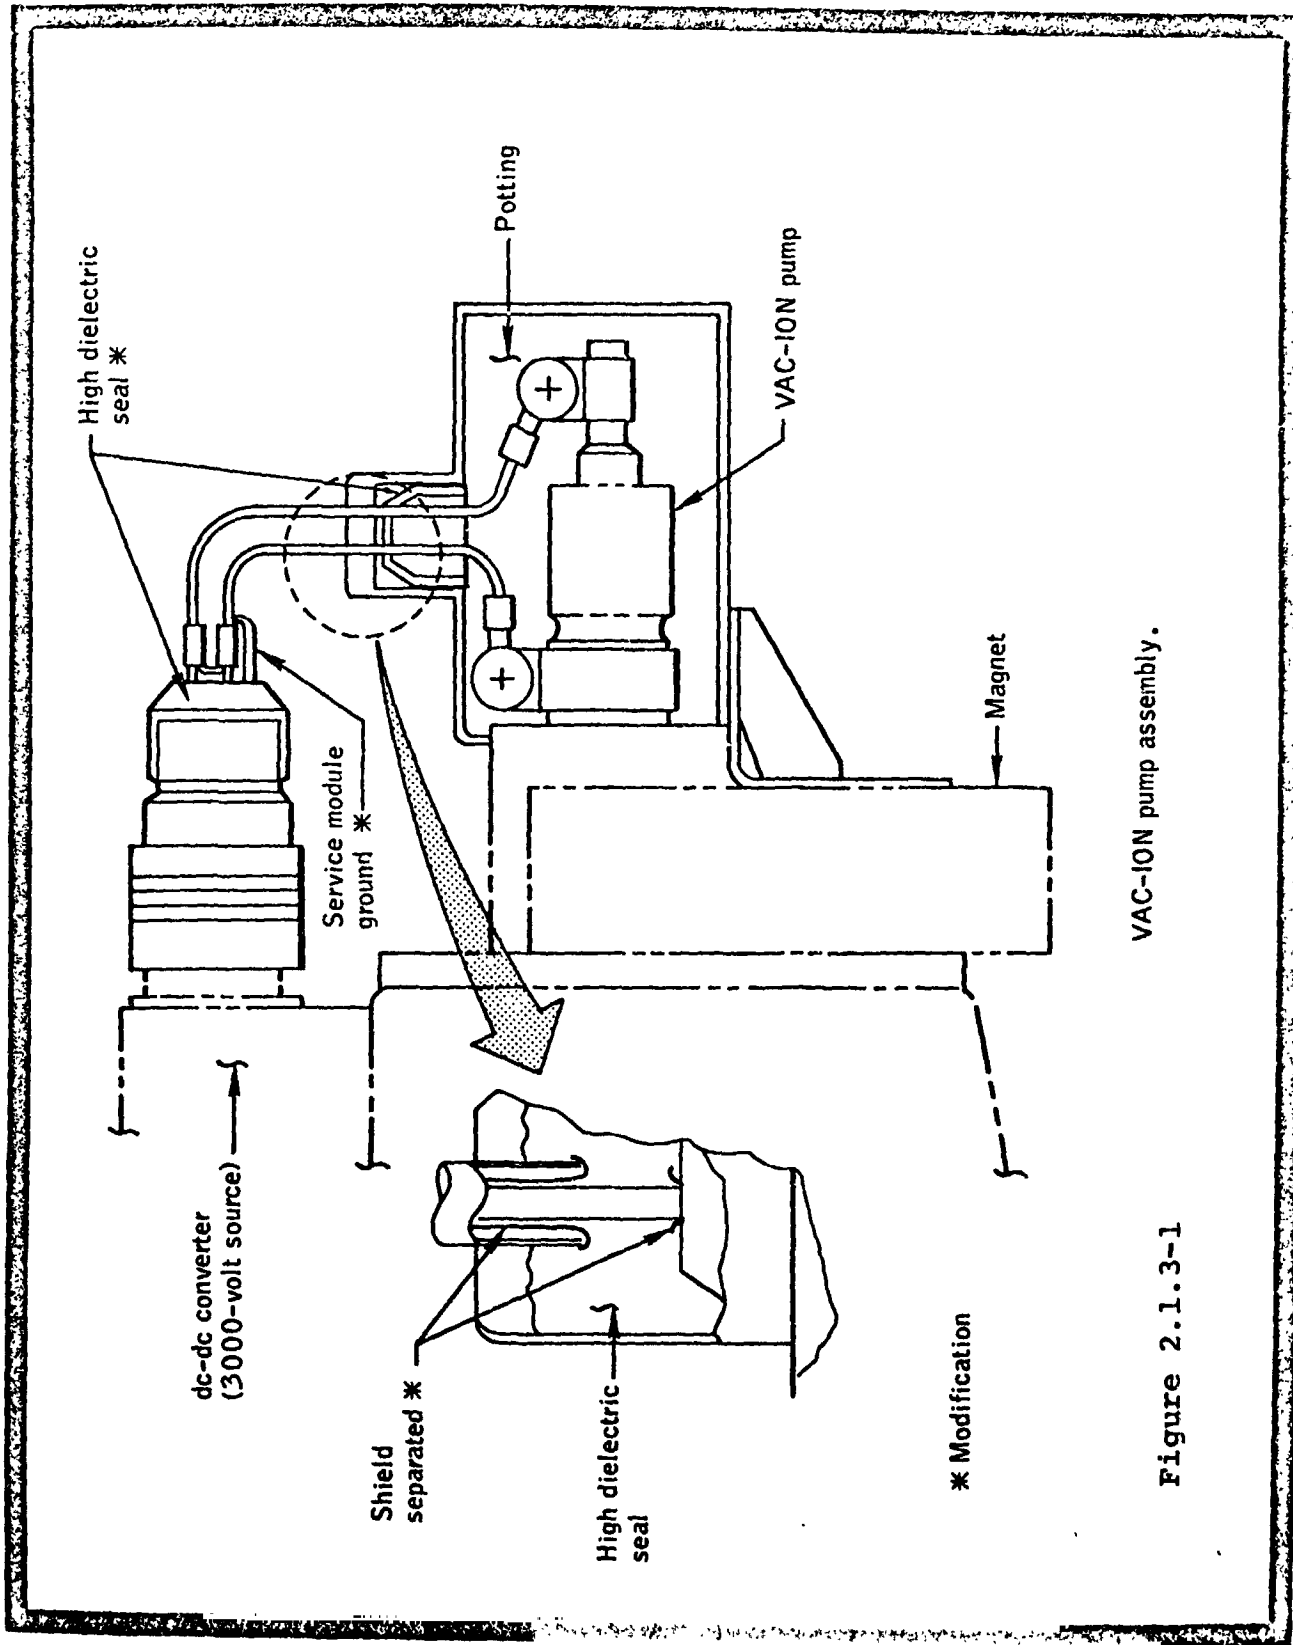
Figure 2.1.3-1

VAC-ION pump assembly.

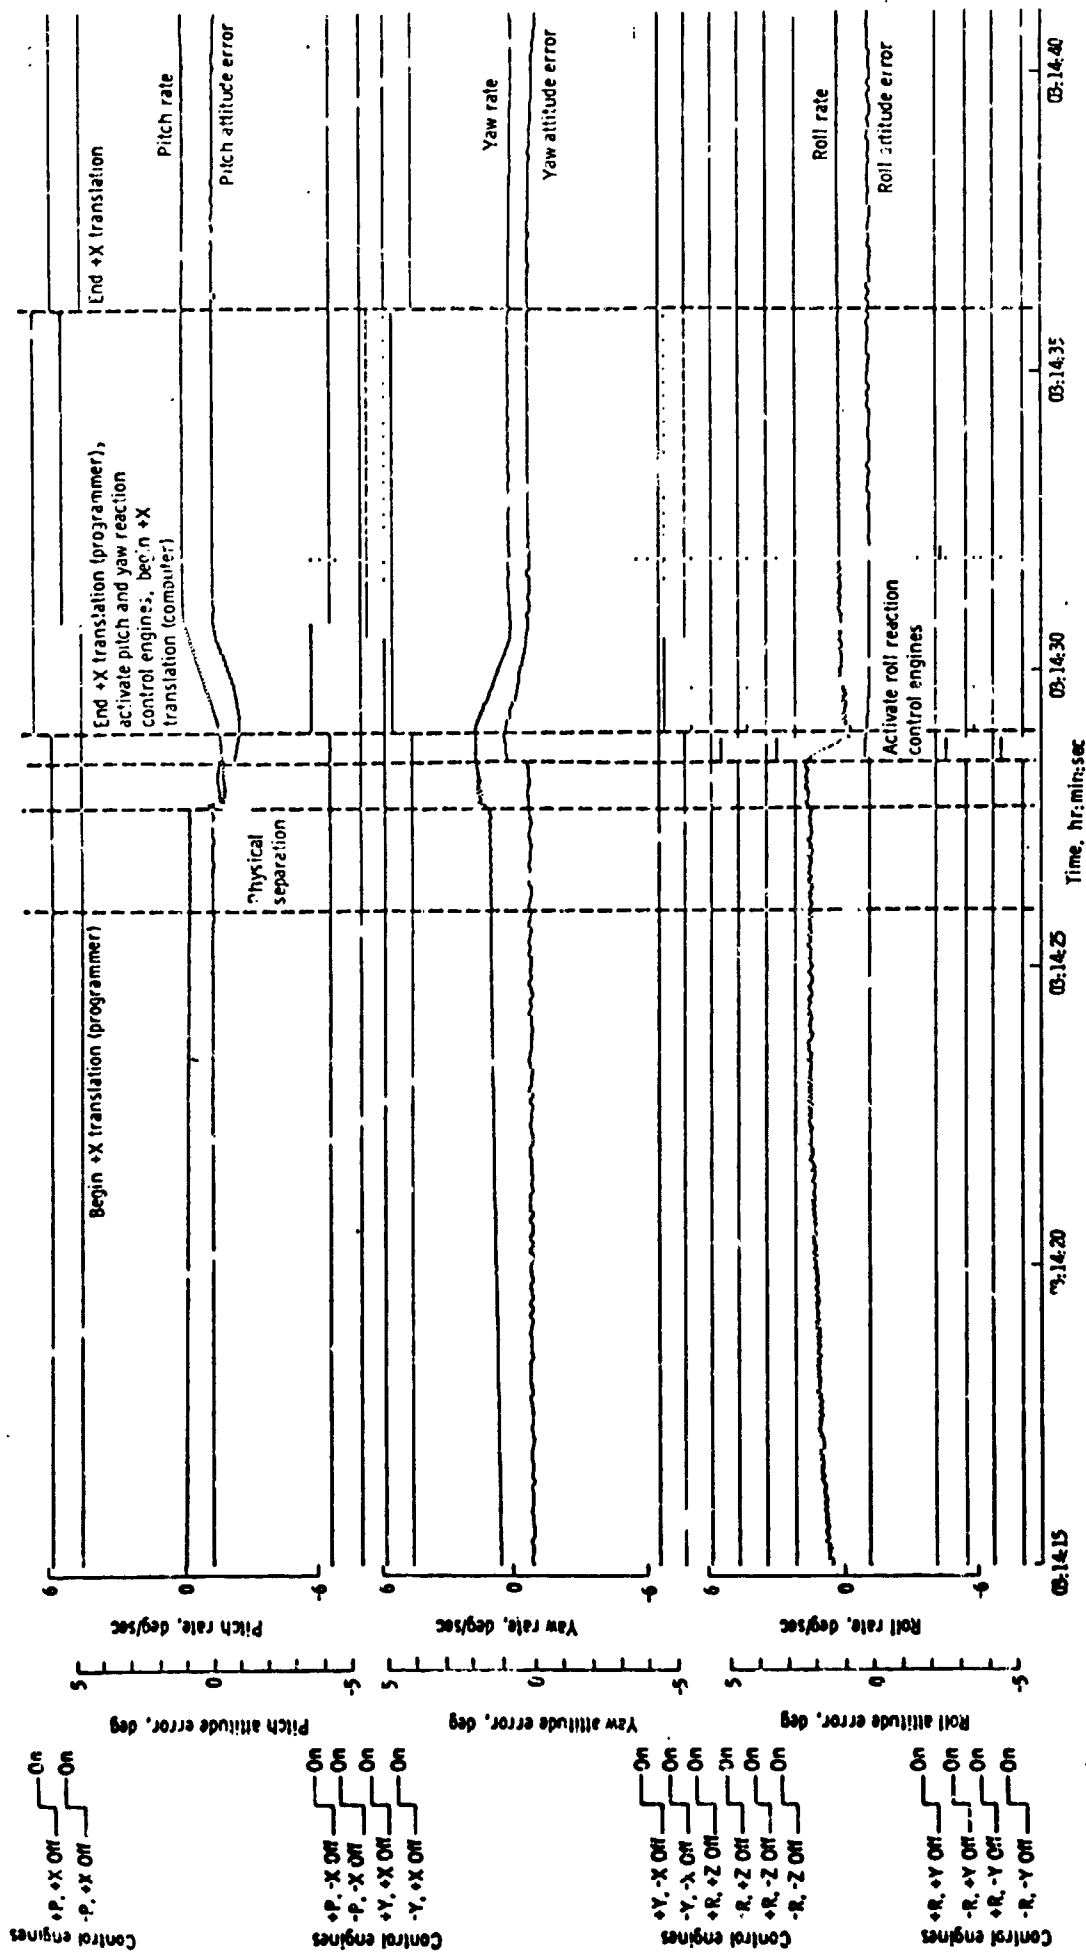
Figure 2.1.18-1. Dynamics During CSM/S-IVB Separation

CSM/S-IVB SEPARATION TRANSIENT

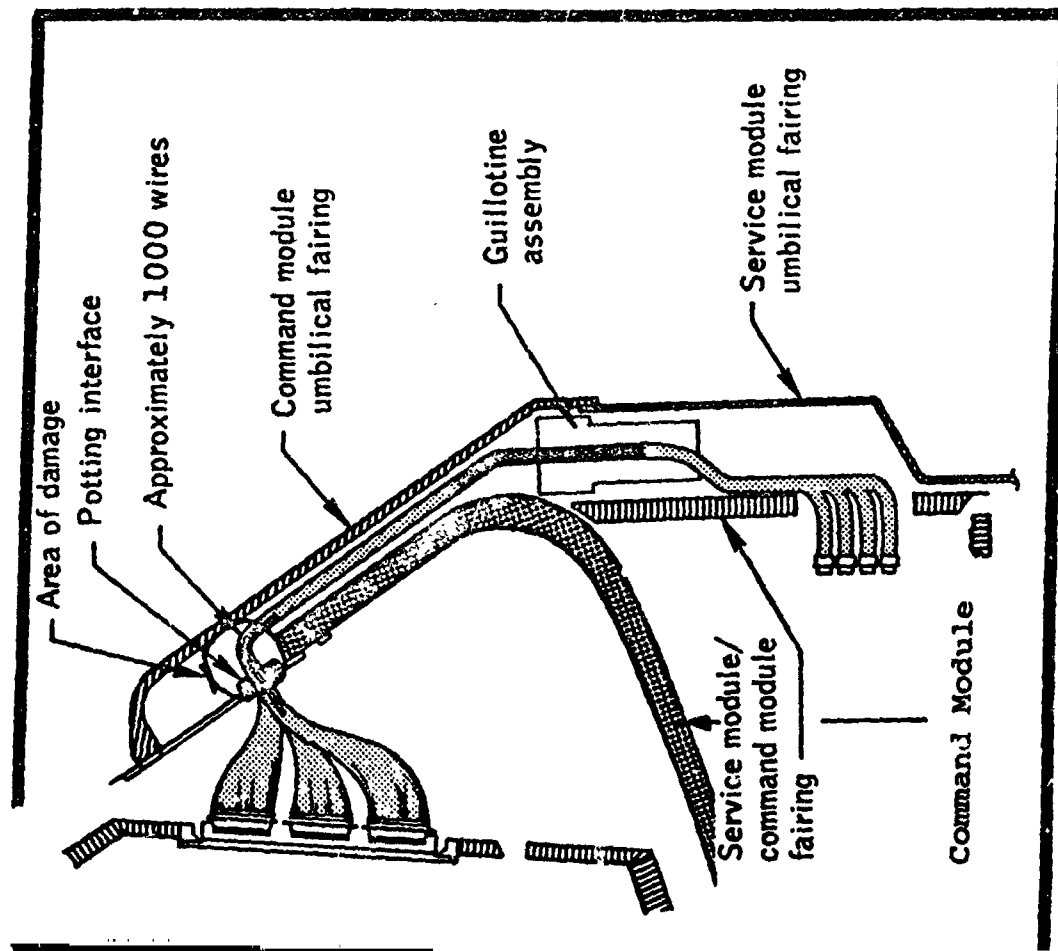
Figure 2.1.20-1. CM/SM Umbilical

TITLE: DAMAGED WIRES IN CM/SM UMBILICAL

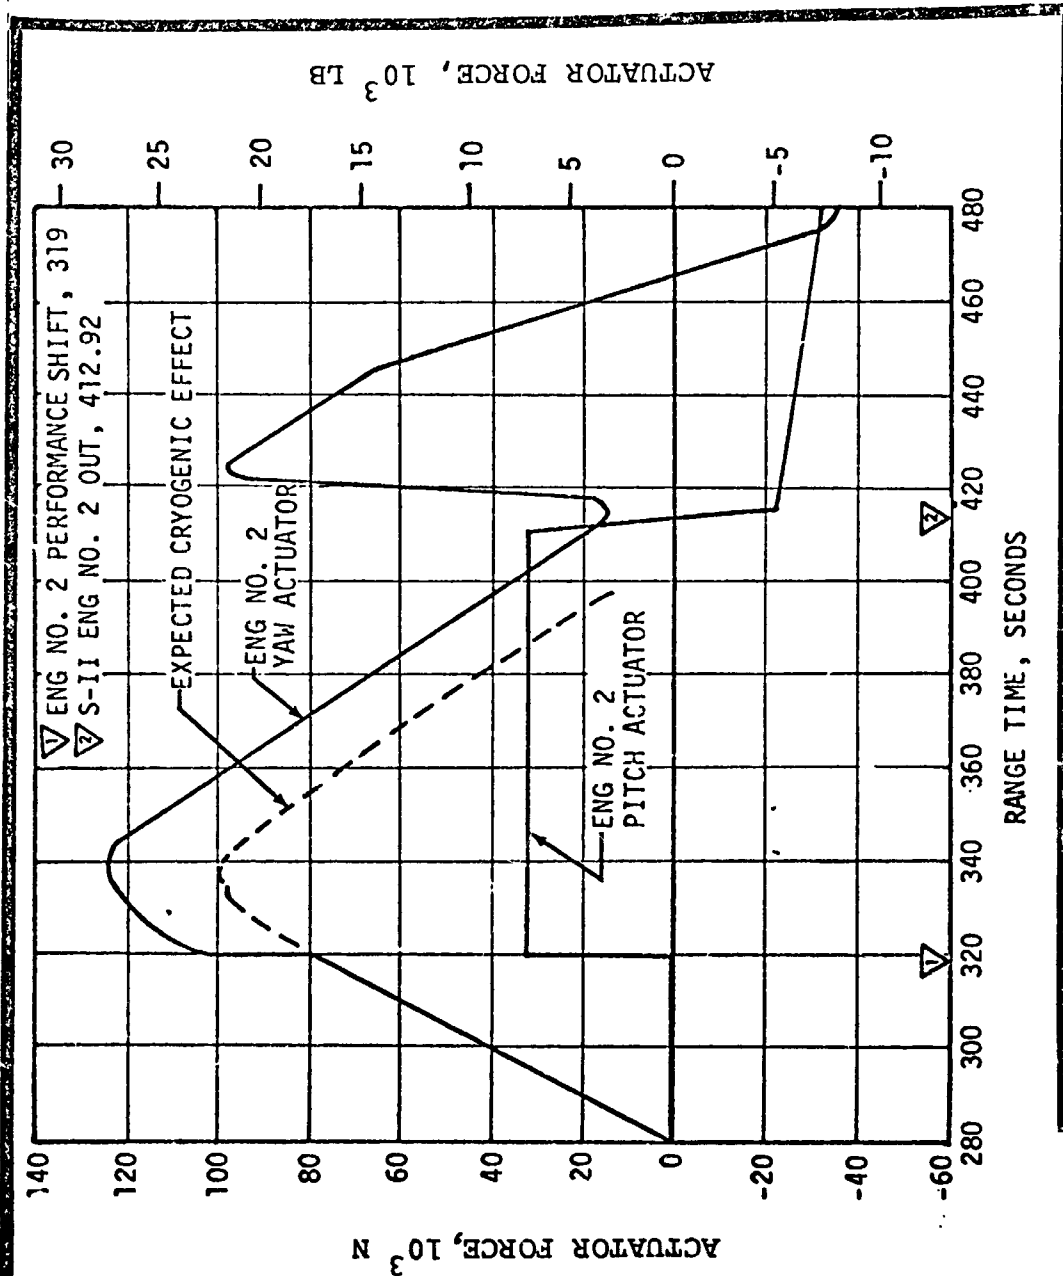
FIGURE 2.2.3-1 NUMBER 2 ENGINE ACTUATOR FORCES

AT 280 SECONDS, THE ENGINE NUMBER 2 YAW ACTUATOR DIFFERENTIAL PRESSURE MEASUREMENT STARTED A POSITIVE RAMP INCREASE AS SHOWN IN FIGURE 2.2.3-1. THIS INDICATION WAS APPARENTLY NOT A MEASURE OF INCREASING PRESSURE, BUT WAS THE RESULT OF CRYOGENIC FLUID COMING IN CONTACT WITH THE TRANSDUCER. THIS EFFECT HAS BEEN REPRODUCED IN TESTS PERFORMED AT MSFC AND AT THE S-II STAGE CONTRACTORS' TEST FACILITY. THE TRANSDUCER UTILIZES TWO BOURDON TUBES TO SENSE PRESSURE DIFFERENCE. IN THE TESTS LIQUID NITROGEN SPRAYED ON THE ACTUATOR CAUSED THE INSTRUMENT TO SHOW A PRESSURE DIFFERENCE SIMILAR TO THAT SHOWN IN FIGURE 2.2.3-1, ALTHOUGH NO PRESSURE WAS APPLIED TO THE ACTUATOR. THE INDICATION ROSE, PEAKED, AND THEN DECAYED APPARENTLY BECAUSE ONE OF THE BOURDON TUBES WAS COOLED FIRST AND THEN THE OTHER. WHEN BOTH TUBES HAD BEEN COOLED TO THE SAME TEMPERATURE, INDICATIONS ARE THAT THE TRANSDUCER WAS AGAIN ABLE TO MEASURE DIFFERENTIAL PRESSURE.

TITLE: INCREASE IN PITCH AND YAW ACTUATOR DIFFERENTIAL PRESSURE (CONTINUED)

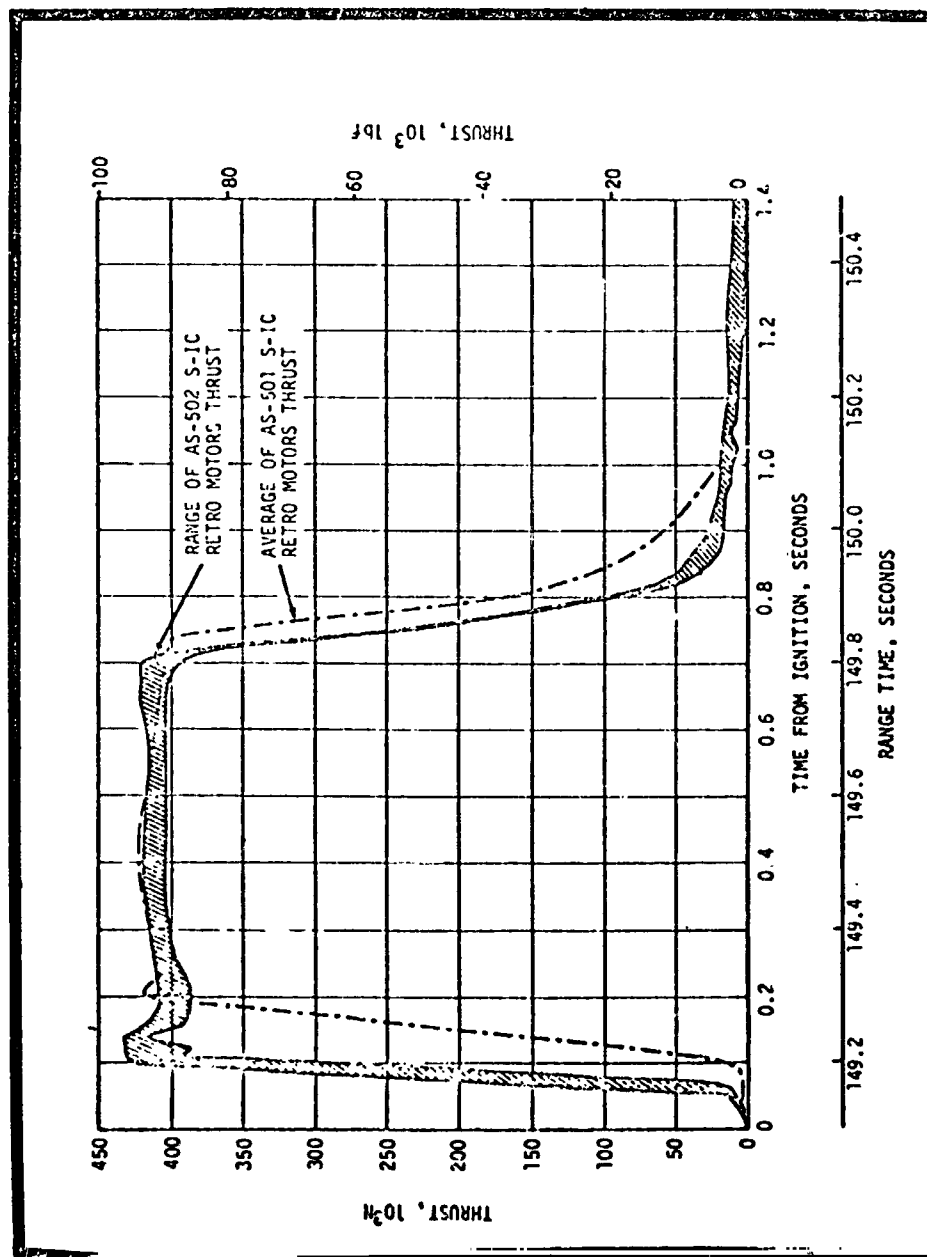
Figure 2.2.13-1. S-IC Retro Motor Thrust

STATUS: THE LONGITUDINAL ACCELERATION INDICATED THAT PHYSICAL SEPARATION OCCURRED APPROXIMATELY 0.1 SECOND EARLIER THAN AS-501. THIS WAS DUE TO THE RETRO MOTOR THRUST RISING TO FULL THRUST 0.1 SECONDS EARLIER. (SEE FIGURE 2.2.13-1.) GOOD AGREEMENT BETWEEN CALCULATED RESULTS AND FLIGHT DATA EXISTED FOR THIS FLIGHT. MSFC DOES NOT CONSIDER THIS TO BE AN ANOMALY.

TITLE: HIGH RETROCKET PERFORMANCE

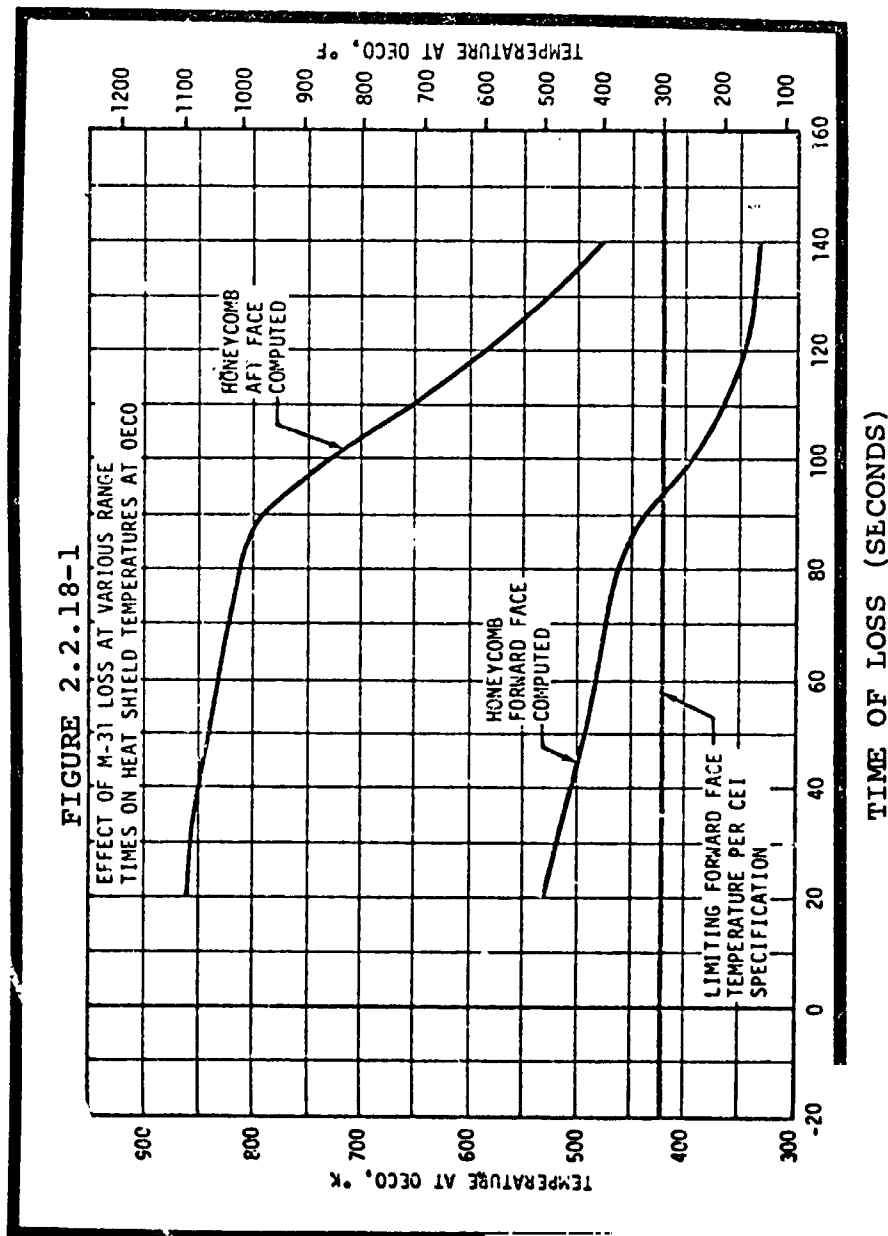
M-31 INSULATION LOSS WHICH OCCURRED AT 110 SECONDS ON AS-501 AND 95 SECONDS ON AS-502 APPEARS TO BE A RANDOM PROCESS, AND IT MAY OCCUR AT ALMOST ANY TIME DURING FLIGHT. THE EFFECT OF THIS LOSS AT VARIOUS TIMES WAS COMPUTED AND THE RESULTS ARE PRESENTED IN FIGURE 2.2.18-1. NOTE THAT THE LOSS OF M-31 AT 20 SECONDS WOULD RESULT IN OUTBOARD ENGINE CUTOFF TEMPERATURES OF 1094°F AT THE AFT HONEYCOMB FACE SHEET AND 504°F AT THE FORWARD HONEYCOMB FACE SHEET. THE MAXIMUM ALLOWABLE TEMPERATURE FOR THE FORWARD FACE SHEET IS 300°F. HOWEVER, THIS IS INTERPRETED AS A DESIGN GOAL AND TESTING SHOWED THE HEAT SHIELD IS CAPABLE OF WITHSTANDING TEMPERATURES ABOVE THIS LEVEL. ACTUAL LIMITS FOR EITHER FACE SHEET ARE NOT DEFINED AT THIS TIME BUT ARE BEING EXAMINED TO DETERMINE WHETHER A POTENTIAL PROBLEM EXISTS. THIS ANOMALY HAS BEEN CLOSED BY MSFC.

TITLE: LOSS OF S-IC BASE HEAT SHIELD INSULATION (CONTINUED)

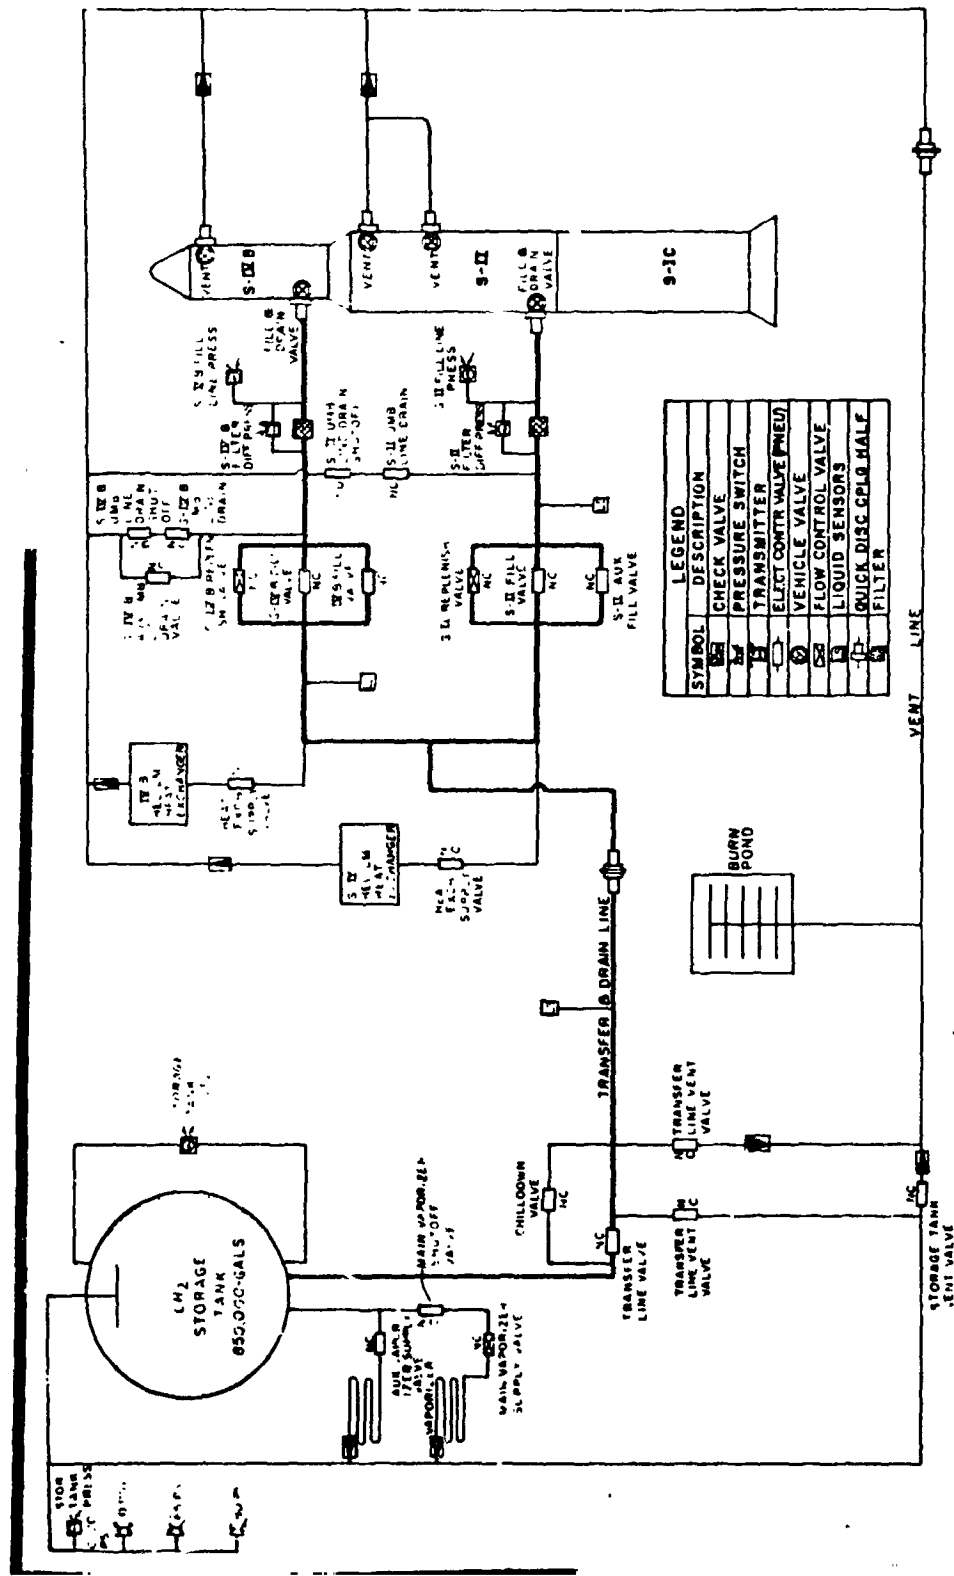
FIGURE 2.3.6 -1. LH₂ SERVICING SYSTEM SCHEMATIC

| <p>STATUS: THIS ANOMALY MAY HAVE BEEN CAUSED BY INSUFFICIENT HELIUM PURGE, LEAVING COLD PIPING WHICH CAUSED THE HELIUM IN THE VENT LINES TO CONTRACT ONCE THE PURGE WAS TERMINATED. THIS LOWERED THE PRESSURE IN THE VENT SECTION AND INITIATED THE SIPHONING ACTION (SEE SYSTEM SCHEMATIC, FIGURE 2.3.6-1). PROCEDURES HAVE BEEN CHANGED BY KSC (ECP 0332-3) TO EXTEND THE DURATION OF THE HELIUM PURGE OF THE VENT TRANSFER LINES EFFECTIVE ON AS-503. THE OTHER POSSIBLE CAUSE IS THE DYNAMIC BEHAVIOR OF THE VENT GASES WHEN HIGH VENT GAS FLOW RATES ARE INTERRUPTED. A SIPHON BREAKER WHICH WILL PREVENT NEGATIVE PRESSURE IN THE VENT LINES ARISING FROM ANY CAUSE WILL BE INSTALLED FOR AS-505. THIS ANOMALY HAS BEEN CLOSED BY KSC.</p> | | |

TITLE: WATER IN LH₂ VENT SYSTEM (CONTINUED)
